MPLAB® Debugger Adapter Board AVR Interface Modification

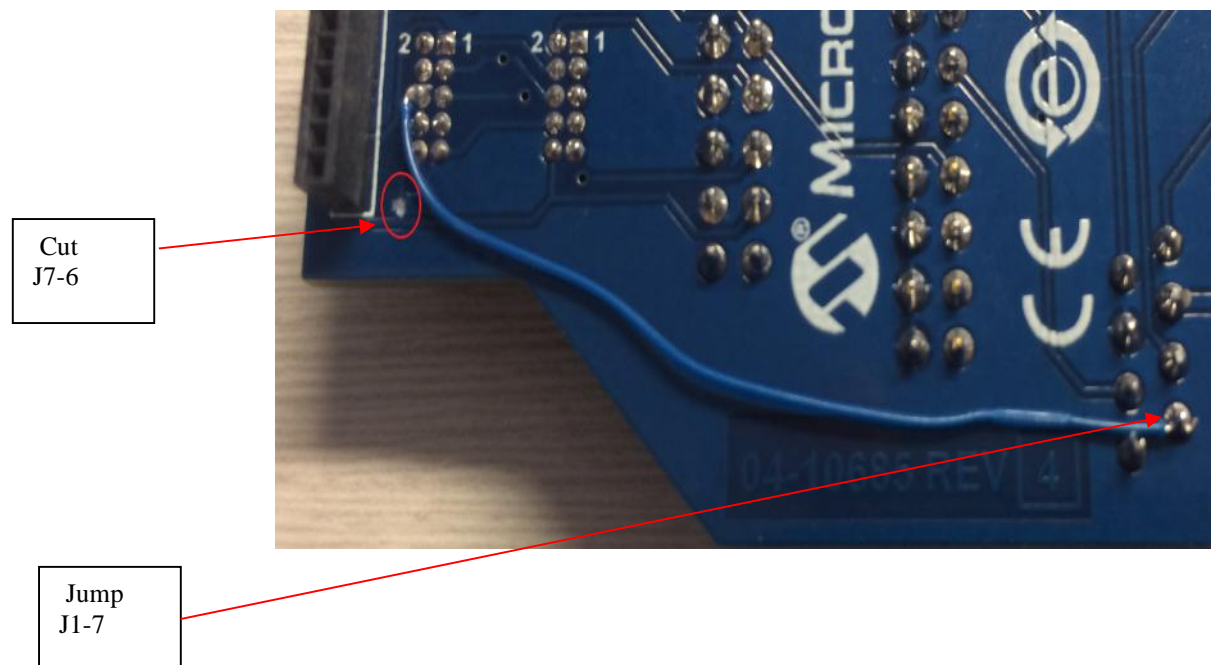
Figure 1

Symptom: Programming and debugging of AVR microcontroller devices that use the PDI, TPI and DebugWire Interface results in a “Connection Failed” message. Assembly #12-10776-R1 (PCB marking REV 4) is mis-wired for AVR interfaces that require the use of the AUX pin.

AVR microcontroller have fragmented programming and debugging interfaces which make use of different pins for different functionality depending on chosen interface. The pinout for RESET on the adapter when using AVR devices can vary from a true RESET, a clock source, or a bidirectional data line. The typical ICSP line NMCLR does not have bidirectional data line capability and is not applicable to serve as a multi-function signal for all these interfaces.

Solution: For AVR interfaces, the AUX line should be used rather than NMCLR for AVR RESET, DATA IO, and Clock pin functionality. This requires a cut and a jump on the J7-6 connector labeled “AVR JTAG”. The jump connects J7-6 pin to J1-7.
